## How to remove a TL7 calibrated leak standard from a XL300 or L300i leak detector

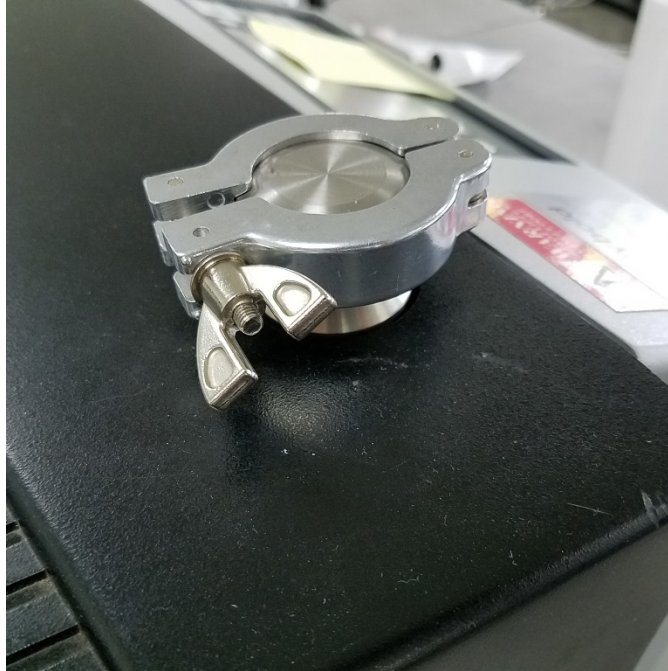
Ensure the unit is powered off and the turbo pump has not been running for at least 3 minutes.  
Removed any attachments or clamps that might be on top of the unit.

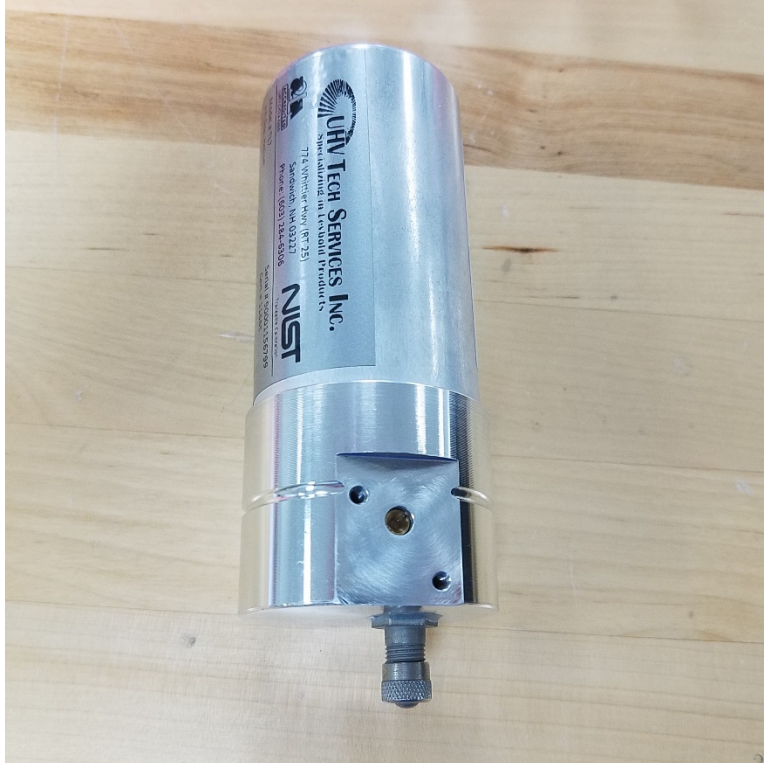
Please properly package just the leak canister below. We recommend double boxing the leak for shipping, it is very fragile and has a breakable membrane inside.

Once they get it back they need to install it and then go into the menu and press menu/settings/vacuum setting/ leak rate internal/ yes to change. Enter the new value and save. Turn the unit on and let it run for 20 minutes. Run a cal by pressing cal. The old cal factor and new should not be that different. They should also spray some helium around the V7 valve once finished to make sure it is leak tight.
